# Turning the Tide For Morro Bay

## COMPREHENSIVE CONSERVATION & MANAGEMENT PLAN FOR MORRO BAY

VOLUME II

# Characterization Morro Bay National Estuary Program

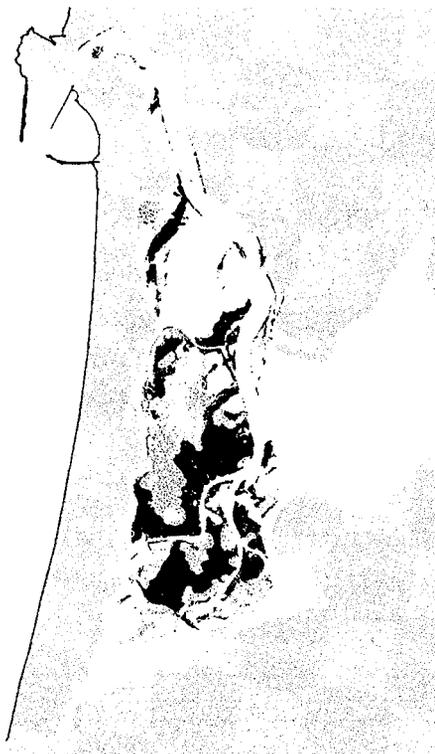
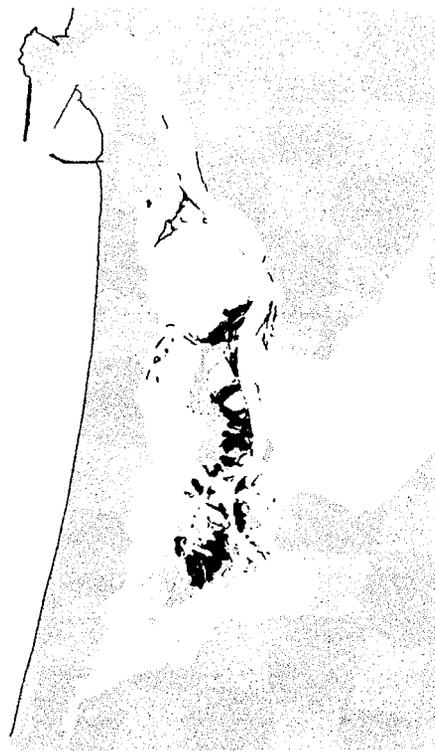
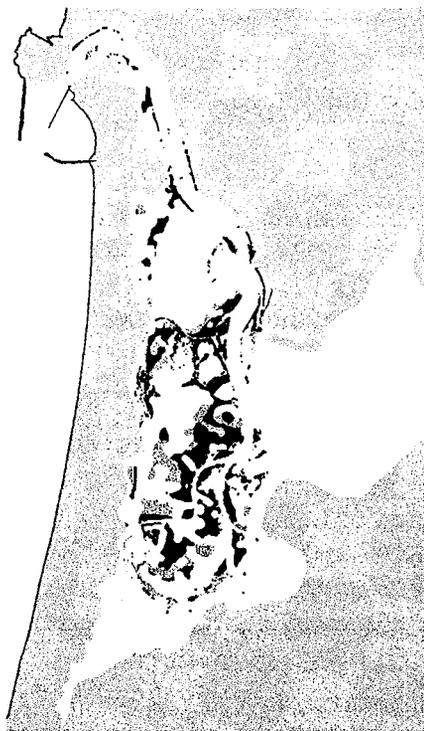
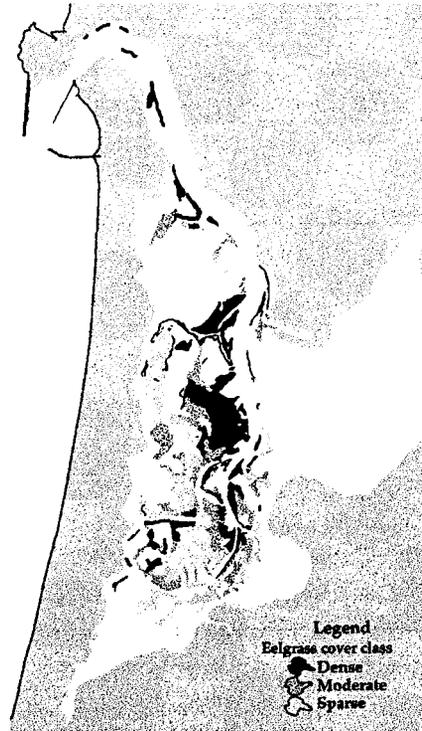
**Fig. 3-4. Changes in abundance and distribution of eelgrass habitat within Morro Bay, before and following the 1994 Highway 41 Fire and March 1995 Flood events.**

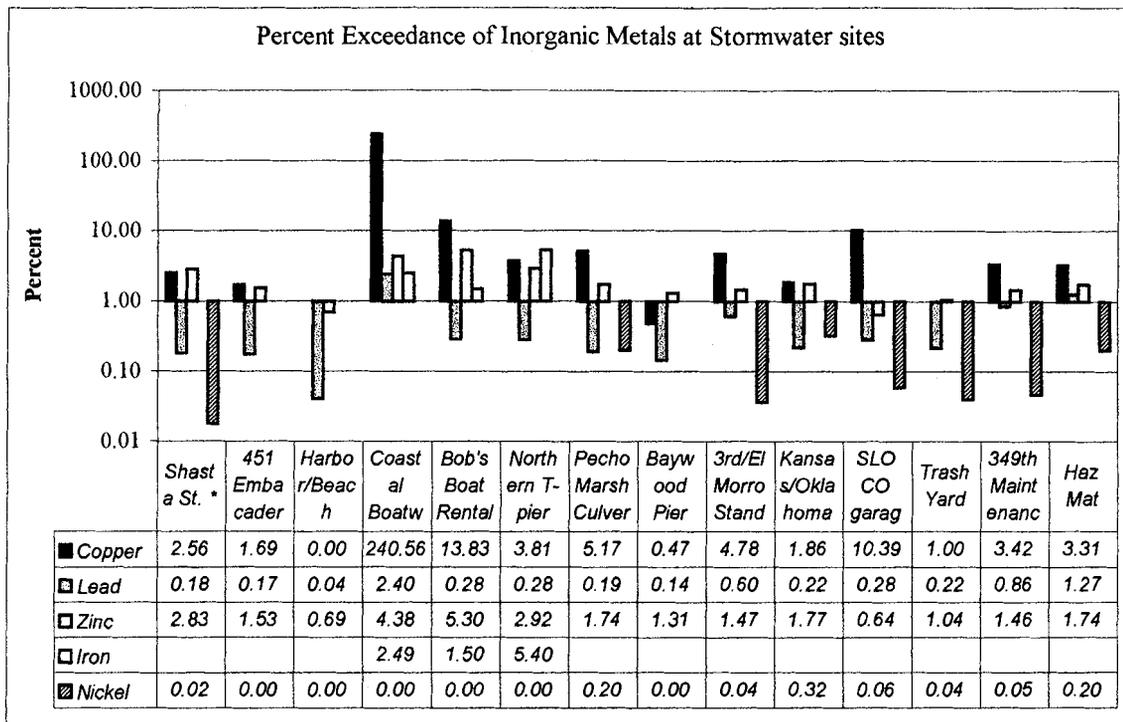
**Figure 9.1 Percent Exceedance by heavy metals of NOAA Screening Criteria (Criteria Maximum Concentrations, and should not be exceed more than once every three years) for freshwater surface waters at Morro Bay watershed stormwater sampling sites. Source: CCRWQCB, Morro Bay Volunteer Monitoring Program and NOAA/Hazmat Screening Tables.**

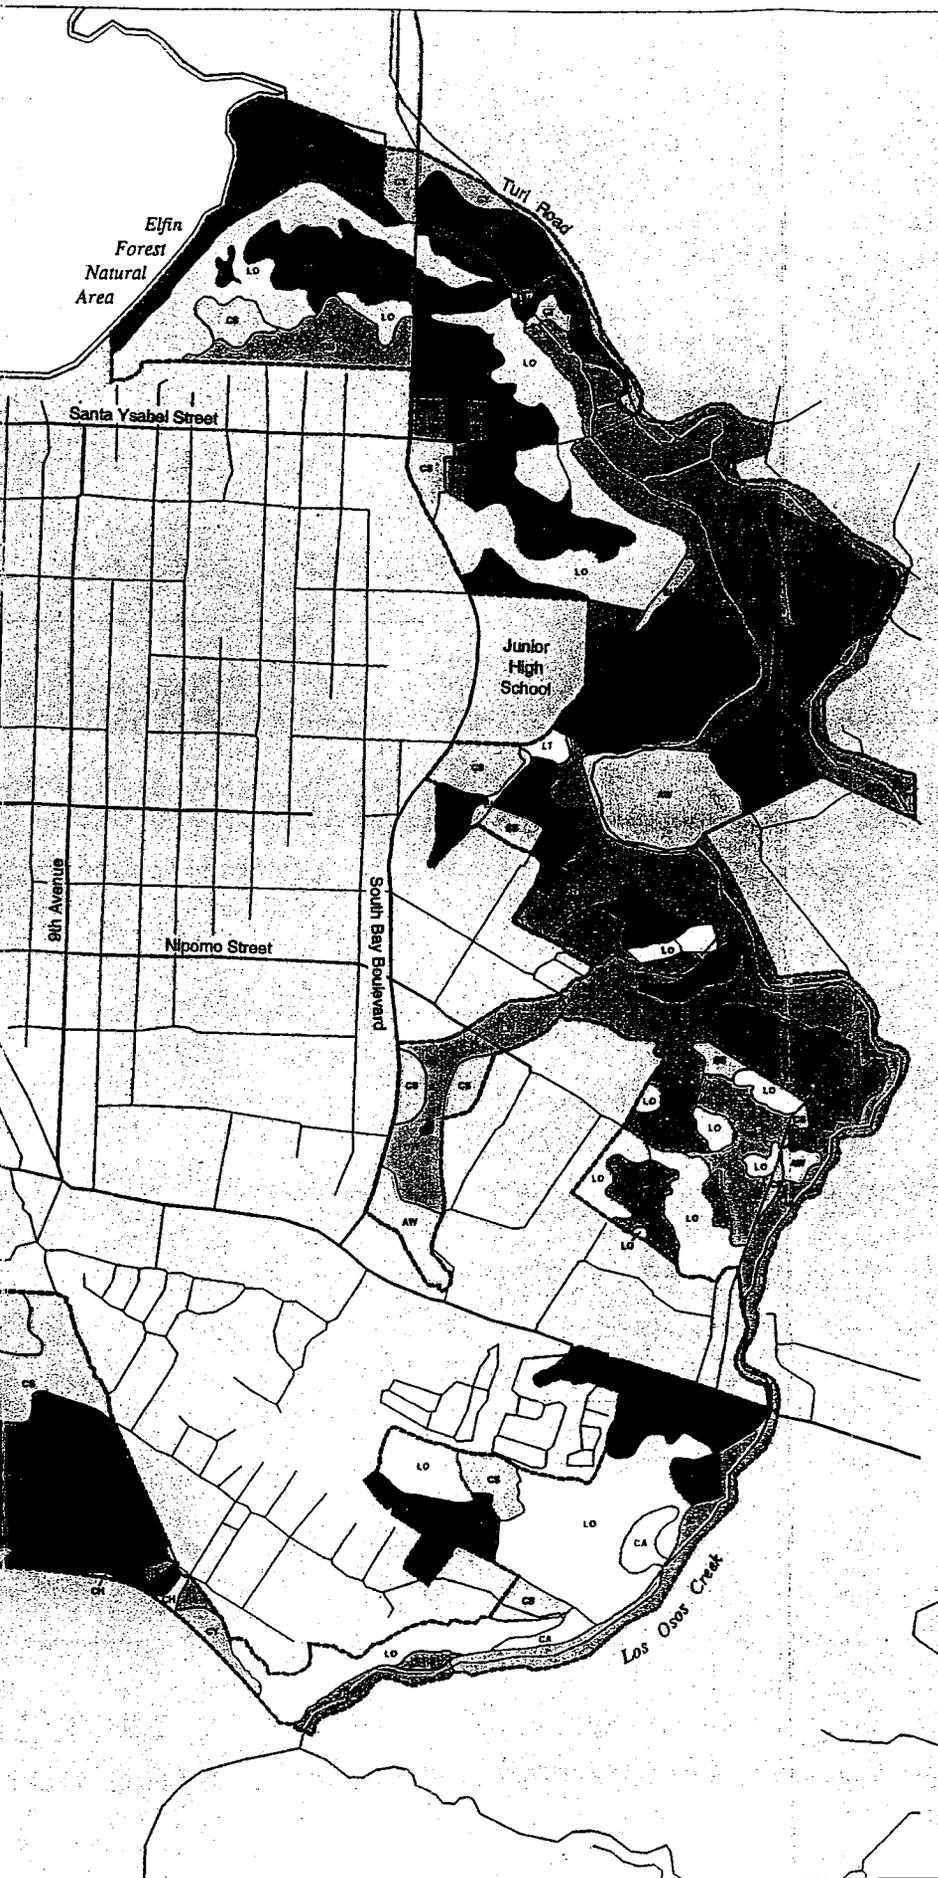
NOTE: This vegetation map of the areas bordering the communities of Los Osos/Baywood Park was prepared by Jones and Stokes Associates, Inc., under contract to the Land Conservancy of San Luis Obispo County. Funding for this project was provided by the State Coastal Conservancy.

**Figure 3.**  
**Plant Community Map of the**  
**Los Osos/Baywood Park**  
**Greenbelt & Conservation Area**

**Figure 3.  
Plant Community Map of the  
Los Osos/Baywood Park  
Greenbelt & Conservation Area**
